NATIONAL ENVIRONMENT AND PLANNING AGENCY
Enforcement Branch Post Planning/Permit/License Monitoring

Inspection Date: 17 December 2015 Report in Series: #3 of 2015

Permitted Activity: Construction and Operation of Hotel or Resort Complex
of 501 rooms or more

Location of Activity: Rutland Pen, Negril, Hanover

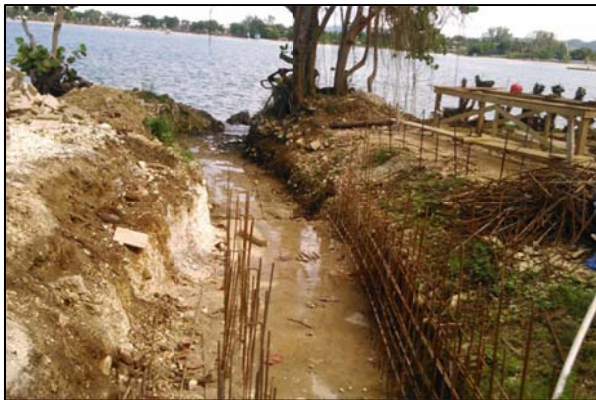
Photo 1. Box culvert under construction in the main existing drain on property. Also note that there is no sediment trap where the drain exits to the sea. (Photo taken by NEPA Officer on 11 December 2015)

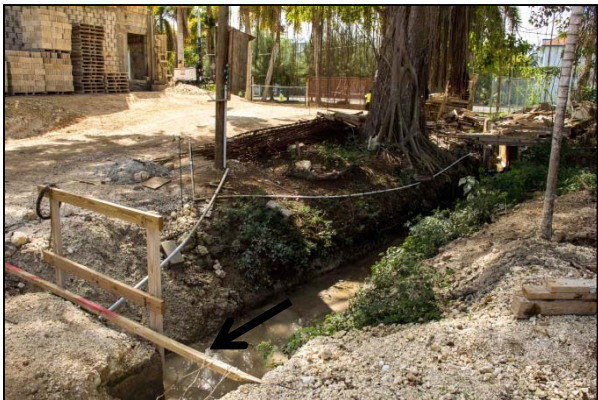
- There is inadequate berm for stockpiles, thus allowing spillover of marl into the marine environment.
- There is no mechanism to prevent runoff of marl or soil into the main drain nor is there is a sediment trap within said drain to prevent direct flow into the adjacent marine environment.
- There were areas in the marine environment where marl was observed deposited on the sea floor (photo 7). Based on observation this was as a result of direct runoff from the site. A site Warning Notice (#0992) was served for breach of the Beach Control Act, 1956

Photo 2. Section of the main drain to show that sediments and runoff from the site can easily get into the drain and into the marine environment. Black arrow shows sediment n drain. (Photo taken by NEPA Officer on 17 December 2015)

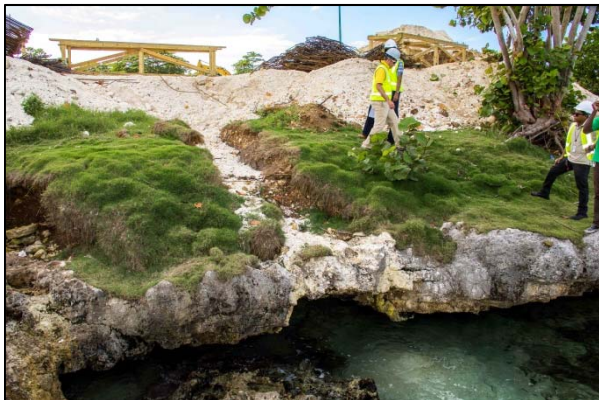
21	The Permittee shall ensure that the parking area is constructed using permeable material and a plan showing the parking area treated with such material shall be submitted to the Local Authority for its approval.	NA	This condition cannot be assessed as construction on the parking facility had not commenced to determine whether or not permeable material had been used.
22	The Permittee shall ensure that surface drainage and storm water run-off generated from the development is effectively intercepted and disposed of within the curtilage of the site.	NC	There was no mechanism to prevent storm water runoff from the site entering into the existing drain (photo 2) which exits directly into the marine environment. There was a section of the property where marl was observed washed down into the marine environment from the property (photo 3). Site Warning Notice served for non-compliance with condition.

32	The Permittee shall during the construction phase wet road surfaces and stockpiles of soil and marl to prevent the generation of fugitive dust.	Full	Stockpiles of materials were damp at the time inspection.
33	The Permittee shall ensure that construction materials are properly stored, bermed and covered on site so as to reduce the incidents of erosion into the adjacent marine environment.	NC	Material deposits were bermed in some areas, however same was inadequate. On a section of the property, marl was deposited into the marine environment from the curtilage of the property (photo 4). The Permittee remains non-compliant despite the issuance of a Site Warning Notice (#8822) preceding a site visit on 11 December 2015.
34	The Permittee shall ensure that construction materials including soil and marl are stored away from surface drainage channels and features.	NC	There was no evidence that the Permittee had put in any measures to comply with the condition previously cited. Marl was observed washed down through a channel into the marine environment (photo 3). As per warning notice (#8822) previously issued the condition was not being met.

Photo 3. Section of the property showing runoff carried down into the marine environment. There is no berm in place or sediment trap. (Photo taken by NEPA Officer on 17 December 2015)

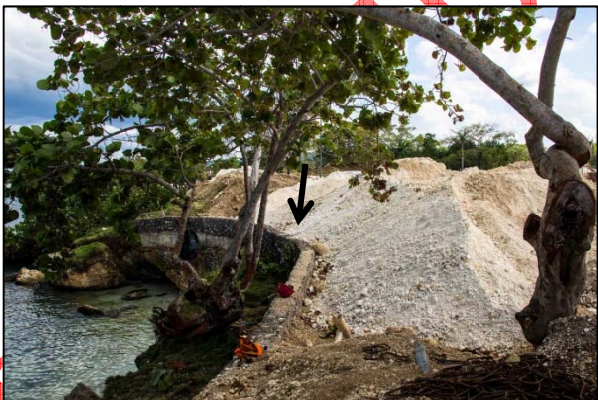
Photo 4. Inadequate berming of storage material. Black arrow shows where there is overspill to the marine environment. (Photo taken by NEPA Officer on 17 December 2015)

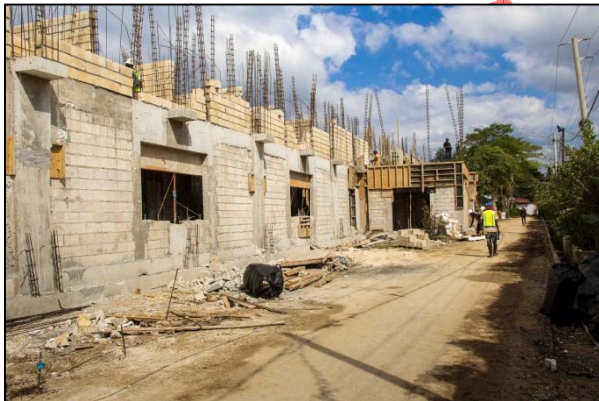
- The setback for building 3 was approximately 4.87m (16ft) contrary to the 8.0m (26ft) as was approved (photo 5)

Photo 5. Inadequate set back from the property boundary. This image is showing building 3 adjacent to the Norman Manley Boulevard (Photo taken by NEPA Officer on 17 December 2015)

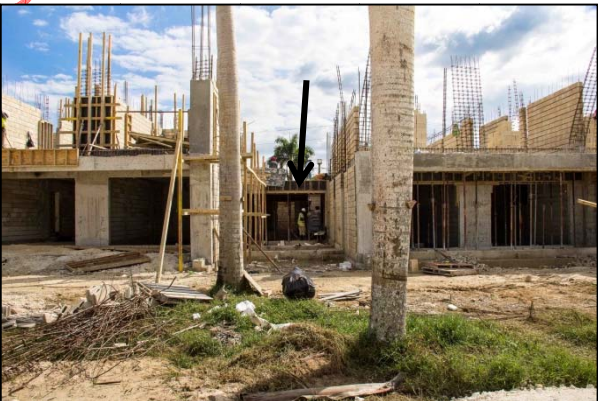
- Between buildings 2 and 3 break is none existent as a structure was being constructed in that area. This was contrary to the approved design (photo 6)
- A similar situation was observed between buildings 12 and 13 (photo 7).

Photo 6. Arrow showing wall that has been constructed between buildings 2 and 3, thus removing the window break to the sea as approved. (Photo taken by NEPA Officer on 17 December 2015)

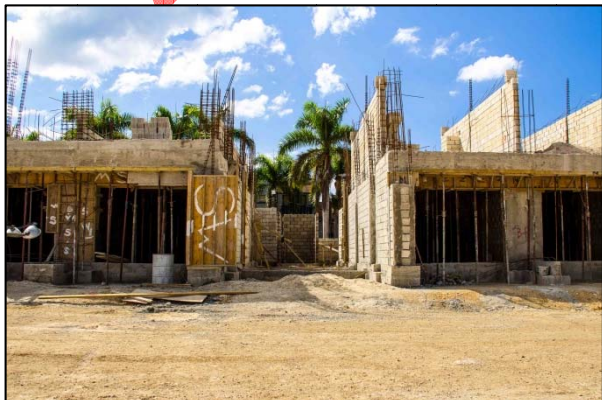
Photo 7. Arrow showing wall that has been constructed between buildings 12 and 13, thus removing the window break to the sea as approved. (Photo taken by NEPA Officer on 17 December 2015)

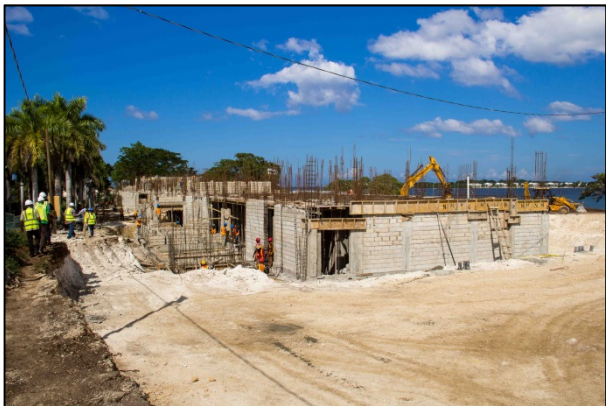
- Buildings 11-13 were not built as illustrated on approved plan i.e. position and outline layout has changed.
- Buildings 14-15 will not be built as was approved, as there is a tree and existing drain in the footprint. The developers have indicated that they will be retaining all trees onsite and as such they will have to revise their drawings for this section. (The revised drawings will need to be assessed & reviewed by the local planning authorities as an amendment before construction)

Photo 9. Panoramic view showing buildings 12 and 13 under construction as well as their current orientation and outline which is contrary to the approved drawings. (Photo taken by NEPA Officer on 17 December 2015)

- A survey diagram showing the location of all existing features on the property including trees and drains
- A revised drainage plan for the site
- Revised plans for the development showing the as-built structures on the property

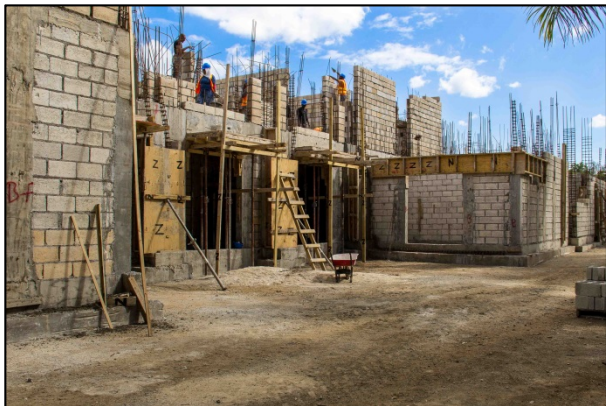
Photo 10. Close up view of a section of building 13 under construction showing the outline which is contrary to the approved drawings. (Photo taken by NEPA Officer on 17 December 2015)

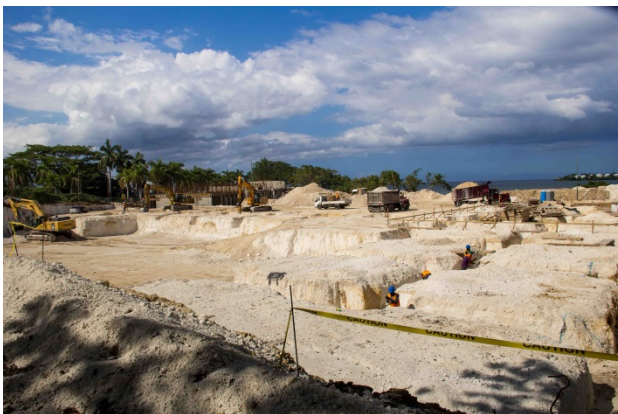
- Main building's layout/outline has changed based on observations on the foundation preparation (photo 11) & same was confirmed by the site manager. Area for underground Water Storage tanks were also being prepared which is contrary to the approved designs

Photo 11. Foundation of main building under construction. (Photo taken by NEPA Officer on 17 December 2015)
